**TM 9-2210**

**SMALL ARMS ACCIDENTS,  
MALFUNCTIONS, AND  
THEIR CAUSES**

**JULY 11, 1942**

WAR DEPARTMENT,  
Washington, July 11, 1942

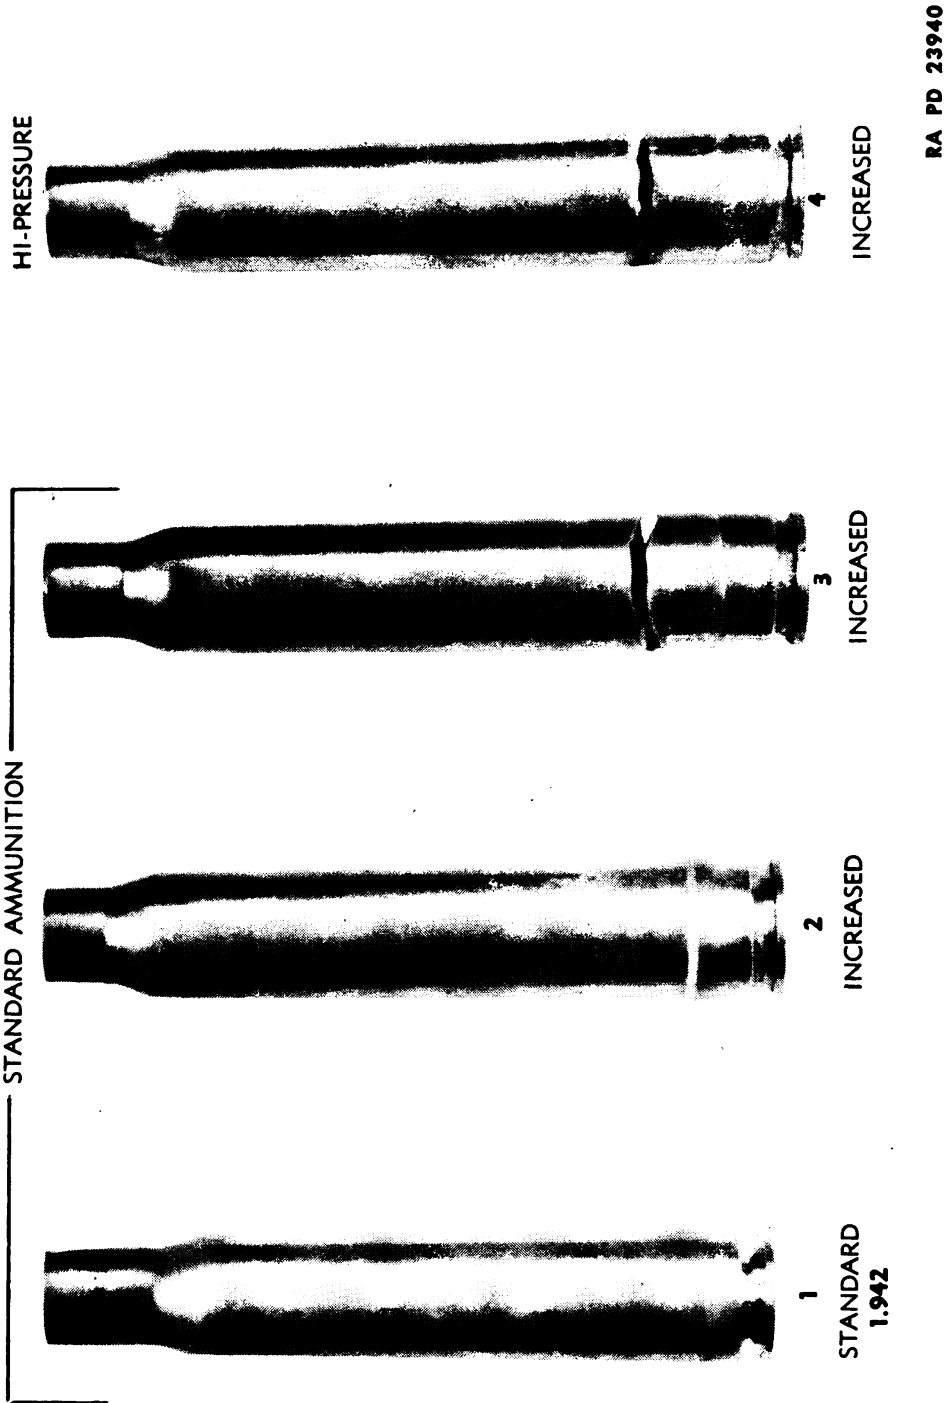
In determining the cause of a small arms failure or malfunction a visual examination of the fired cartridge cases is most important. A frequent cause of ammunition failure is excessive headspace. Figure 1 exhibits typical effects of excessive headspace on fired cartridge cases.

a. Case No. 1 is that of a standard ball cartridge fired in a gun with standard headspace of 1.942 in. The appearance of this case is normal.

b. Cases Nos. 2, 3, and 4 are those of ball cartridges fired in guns having excessive headspace. The gun in each instance was undamaged. In each instance, note the deformation of the forward portions of the case: the lengthening of the first cone and shortening of the third. Such deforming of the case occurs only when the case lies to the rear of its fully chambered position.

(1) Case No. 2 exhibits the effect of  $\frac{1}{4}$  in. excess headspace with ammunition loaded to standard pressures. Note the shortened third cone or case neck and the annular bulge formed on the first cone of the case immediately to the rear of the chamber.

(2) Case No. 3 is that of a standard ball cartridge fired in a gun having  $\frac{3}{16}$  in. excess headspace. Note the separation of the case approximately  $\frac{1}{2}$  in. from the head, and the shortened third cone.

(3) Case No. 4 exhibits the effect of firing a high pressure cartridge in a gun having  $\frac{3}{16}$  in. excess headspace. Note evidence of excessive headspace in the separation approximately  $\frac{1}{2}$  in. from the head of the case and in the shortened third cone. Note evidence of high pressure in the heavy marking of the case by the chamber wall and in the relative sharpness of the newly formed shoulder crest joining the first and second cones.

Figure 1 — Effects of Excessive Headspace, Cartridge Cases, BMG, Cal. .30

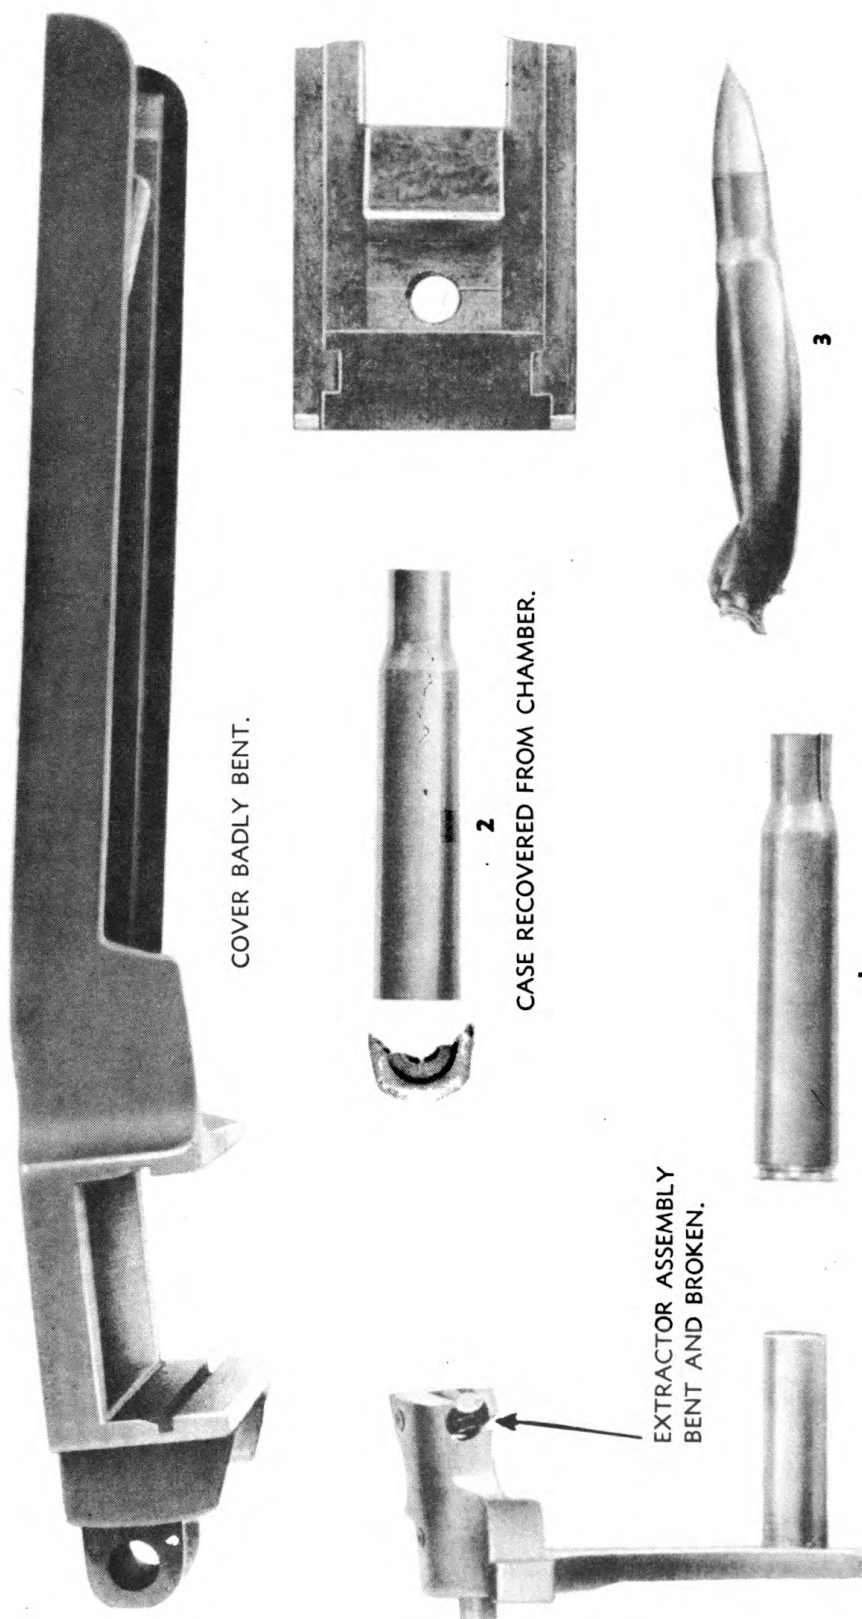
RA PD 23945

a. Cartridge case with split neck. Figure 2 exhibits damage to gun from a round having a case with split neck.

(1) A live round with a split case neck was chambered in the gun. For some reason the bolt was retracted, extracting the case,

Figure 2 — Damage Caused by Round Having Split Neck, BMG, Cal. .30

but leaving the bullet in the chamber. The extracted case was ejected and a second live round chambered. When the chambered cartridge was fired the case ruptured. This explosion ignited the cartridge lying directly above in the feedway, rupturing the case and releasing additional gases into the action.

(2) Damage to the gun is shown clearly in the photograph. Note the bent cover and the bent breech lock cam. Observe the impressions on the cartridge case from the walls of the chamber. The extraction of a live case which left the bullet in the barrel is indicated further by the presence of unburned powder grains in the action.

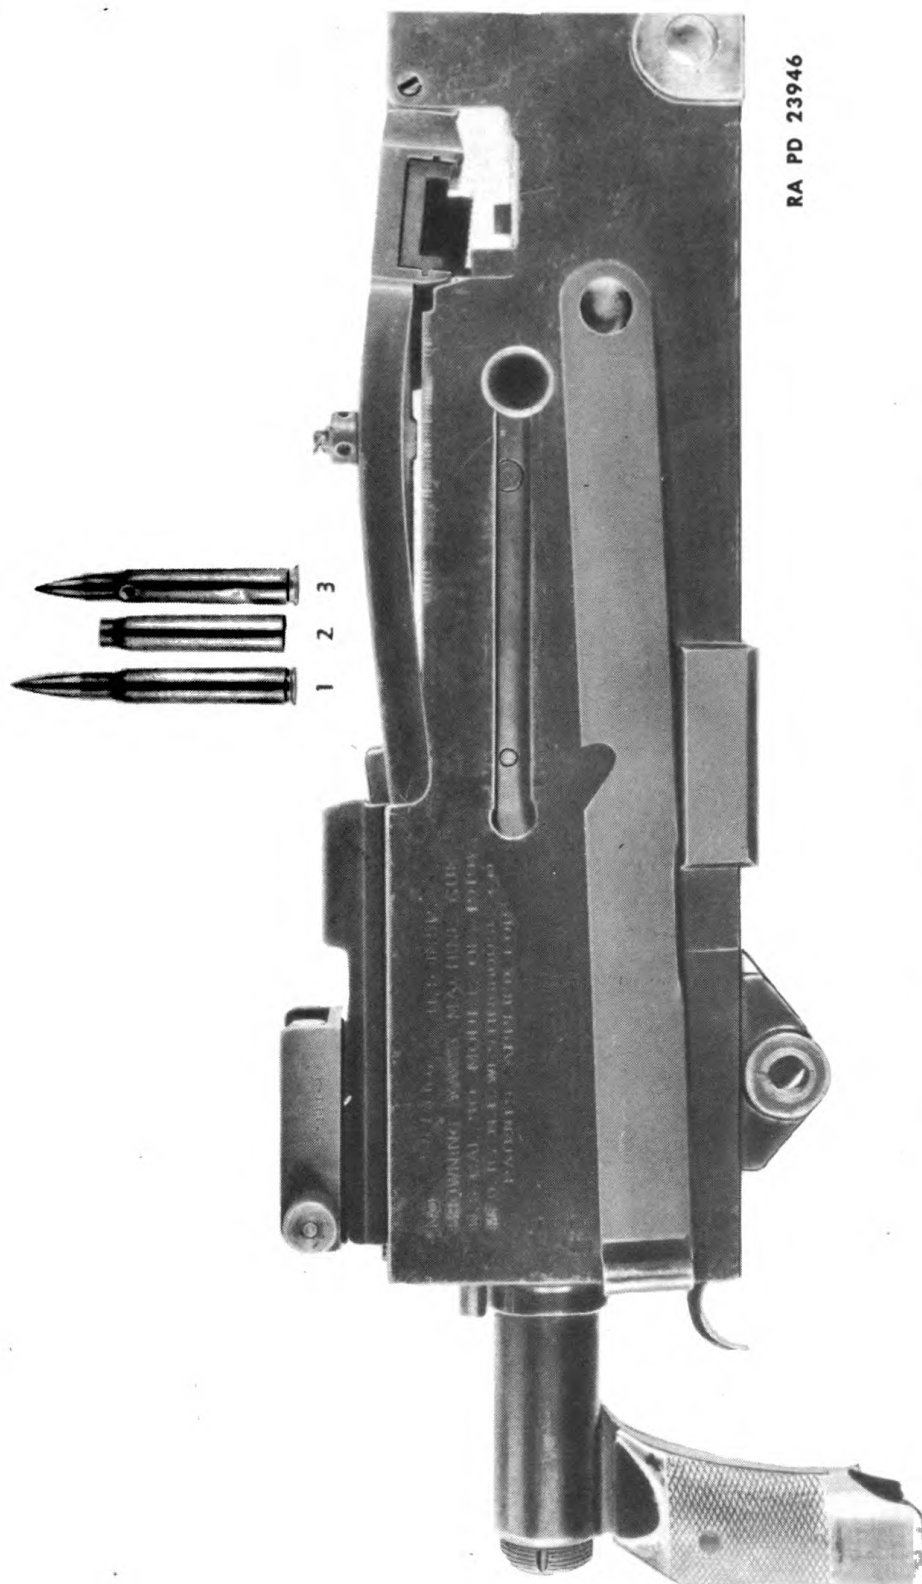
**b. Hangfire.** Figure 3 exhibits damage to gun resulting from a hangfire.

(1) In an attempt to clear the defective round from the gun, the action was retracted by hand sufficiently to unlock the breech bolt and begin extraction of the round from the chamber. At this point in the operation the delayed ignition of the defective round occurred. The resulting explosion separated the case head from the case body. The escaping gases bent the cover of the gun upward.

(2) Cartridge No. 1 is a normal cal. .30 live round. No. 2 exhibits the deformed case body of the chambered round. Note the shortened third cone. No. 3 exhibits a damaged round which, at the time of the explosion, lay in the feedway.

Figure 3 — Damage from a Hangfire, BMG, Cal. .30

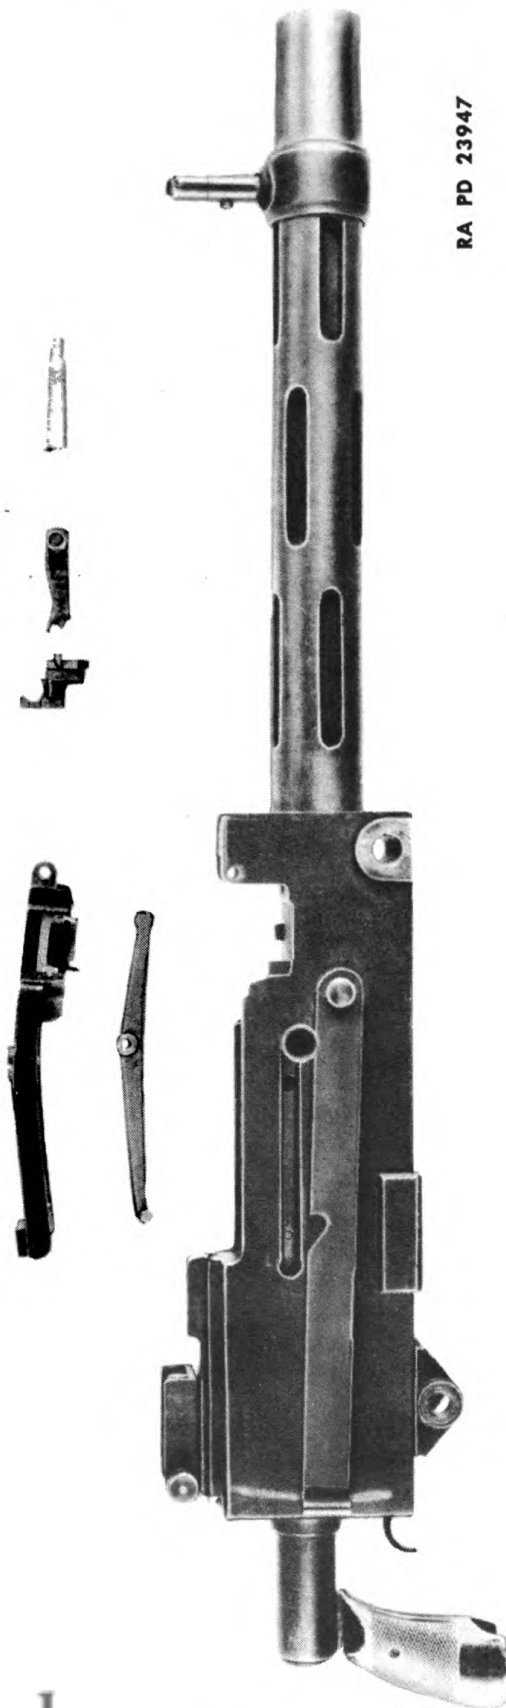
**c. Excessive pressure.** Figure 4 exhibits damage to a gun caused by firing a high-pressure cartridge.

(1) A cartridge which develops excessive pressure will rupture the head of its case. Typical damage to the gun is shown in figure 4. Note broken extractor and bent cover.

(2) In all instances of high breech pressure the fired case will be heavily marked by the walls of the chamber.

(3) Accidents of this type should be attributed to a cartridge developing excessive pressure only after careful examination of the gun and fired cases shows no other cause.

**Figure 4 — Damage from Firing Cartridge with Excessive Breech Pressure, BMG, Cal. .30**

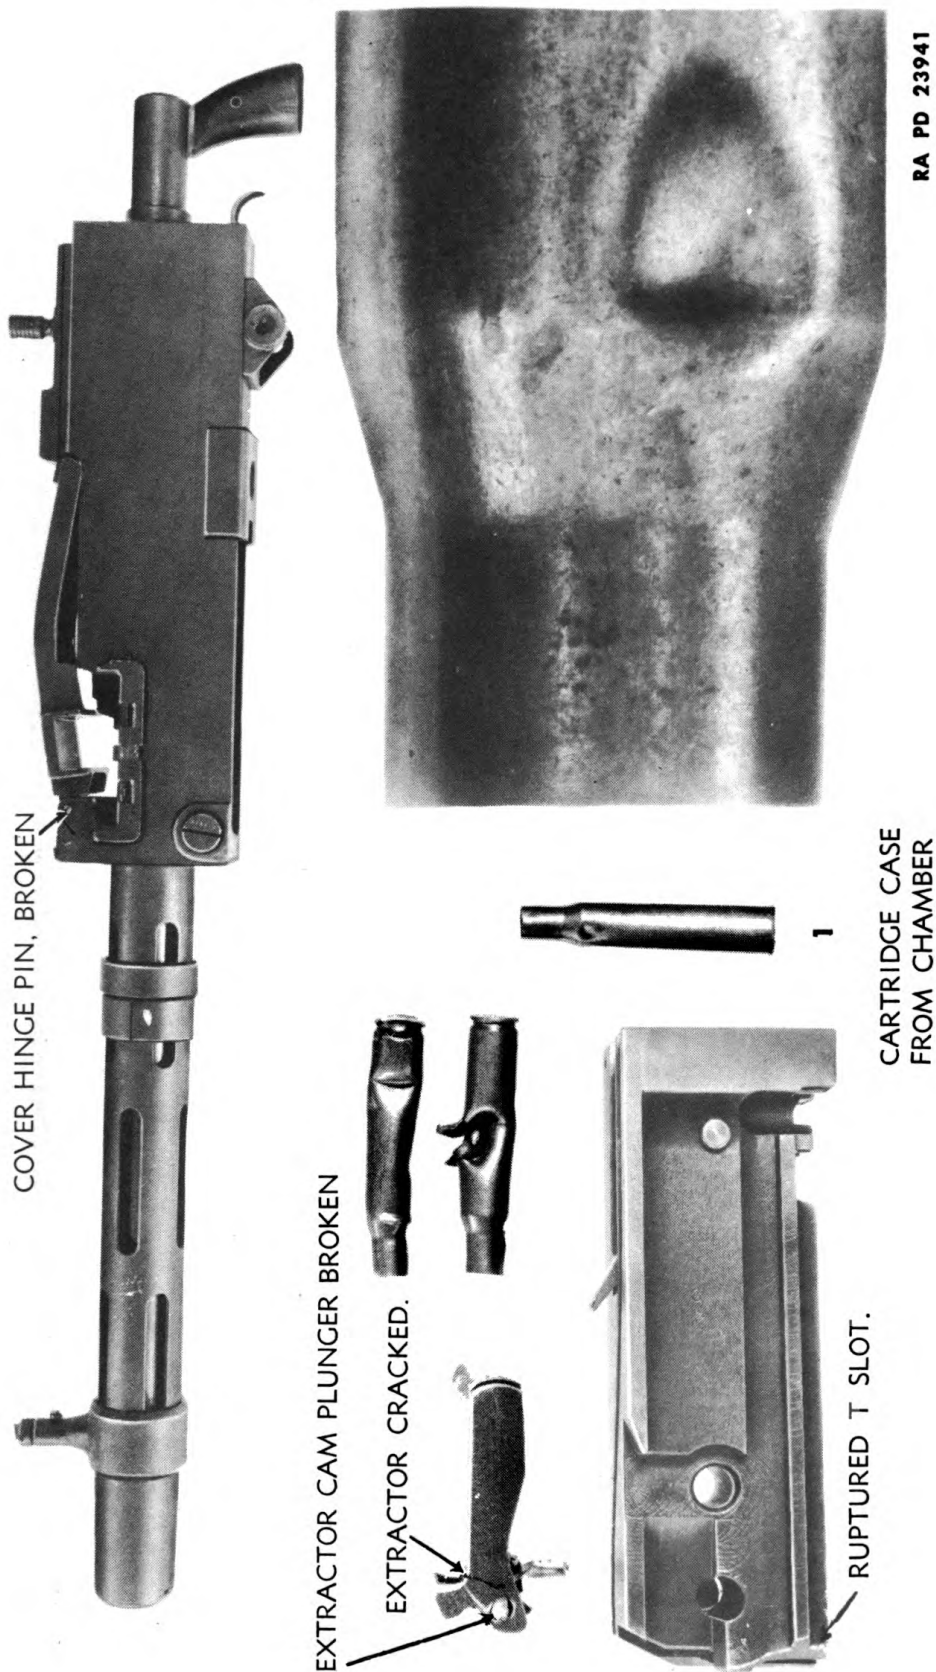
**a. General.** An obstruction in the bore immediately forward of the chambered round may rupture the head of the cartridge case (fig. 5). An obstruction in the long middle portion of the bore may bulge the barrel at the point of the obstruction. If the resistance is sufficiently great the bulge may become a rupture. An obstruction near the muzzle may bulge or split the barrel at the point of the obstruction.

**Figure 5 — Damage from Firing with Obstruction in Bore, BMG, Cal. .30**

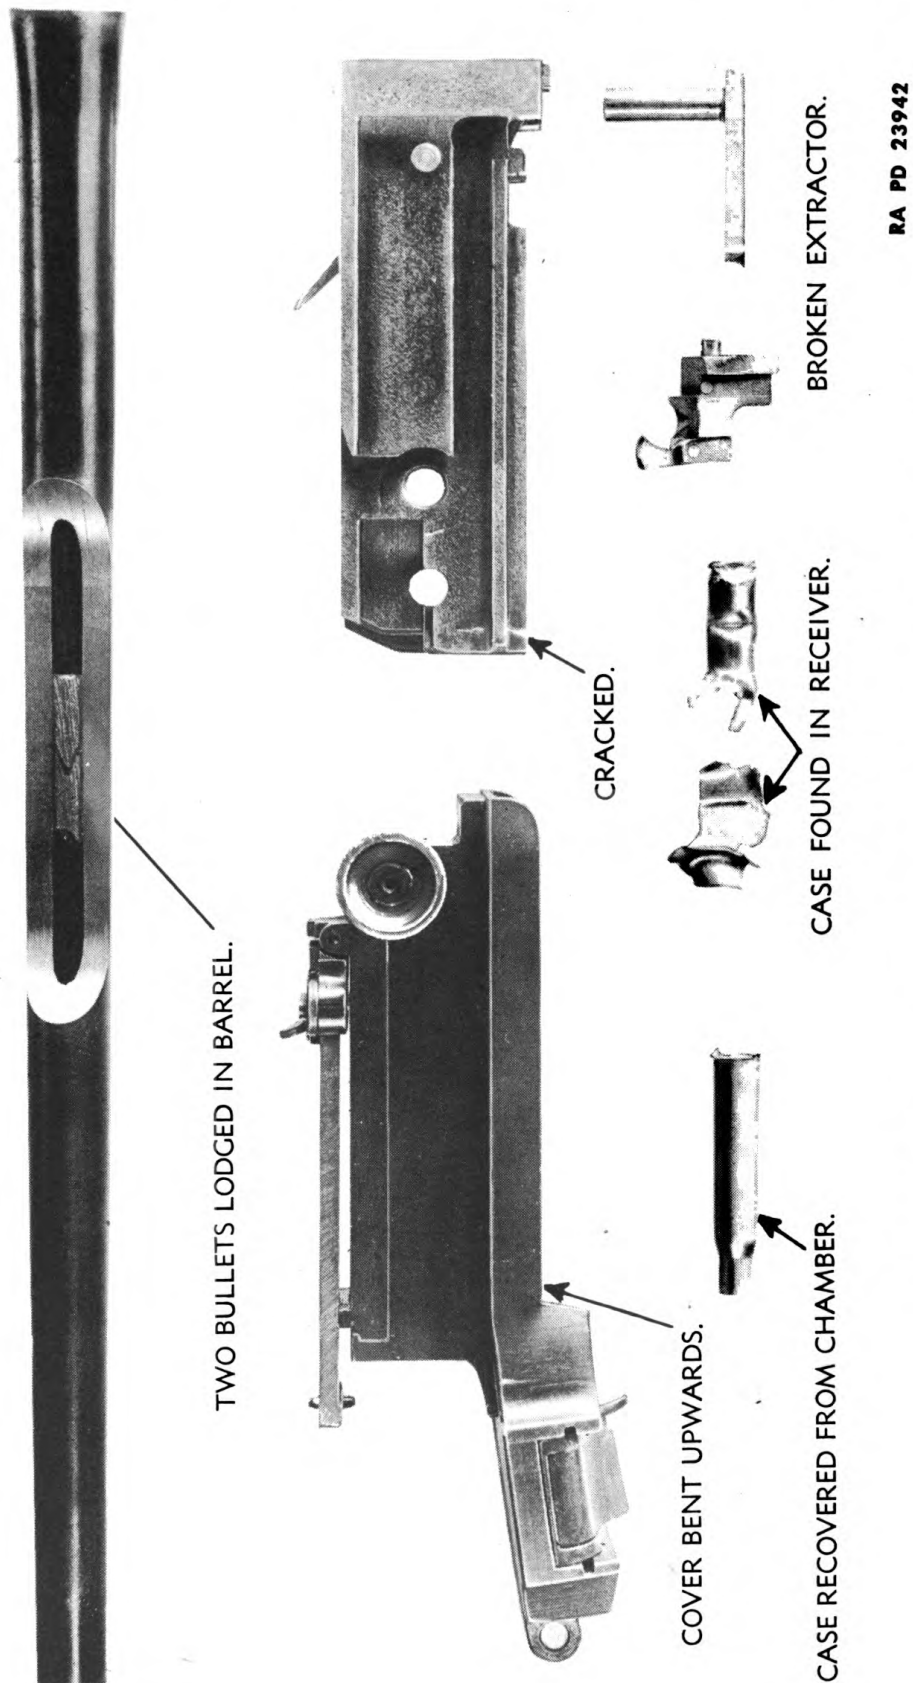
Figure 6 — Damage from Firing with Bullet in Bore, BMG, Cal. .30

b. **Bullet.** A bullet lodged in the bore immediately forward of the chambered cartridge will rupture the head of the cartridge case (fig. 6). A bullet lodged in the middle portion of the bore ordinarily does not rupture the fired case. The case may show signs of high pressure. Ordinarily, the rupture of the case head of the chambered round will ignite the cartridge lying directly above in the feedway. Typical damage from these explosions consists of a fractured T-slot, a cracked or broken extractor, and a bent cover.

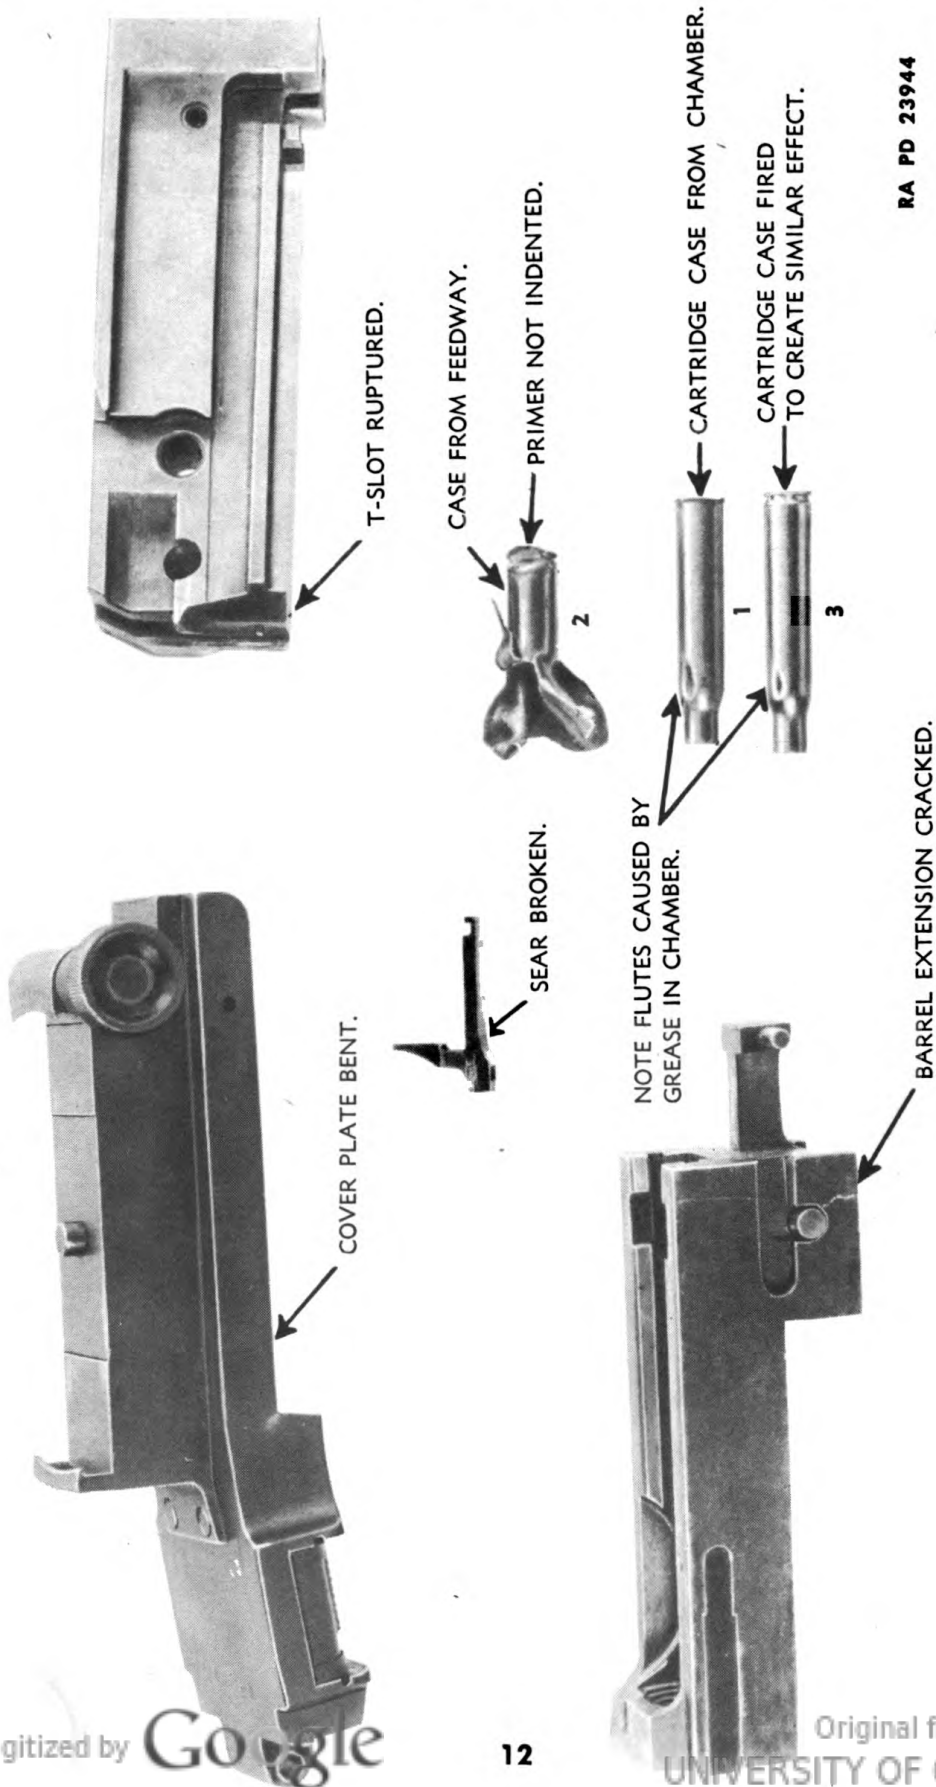
Figure 8 — Damage from Firing with Grease in Chamber and Bore, BMG, Cal. .30

(1) Grease or heavy oil in the chamber invariably produces a flute in the fired case (fig. 8). Note the characteristically elongated and radially contoured shape of these flutes. Case heads will show some indications of high pressure.

(2) Damage to the gun which commonly results from firing with grease in both chamber and breech end of bore is shown in figure 8. The high pressure ruptures the case head, releasing the powder gases into the action. Note fractured T-slot, cracked barrel extension, and bent cover.

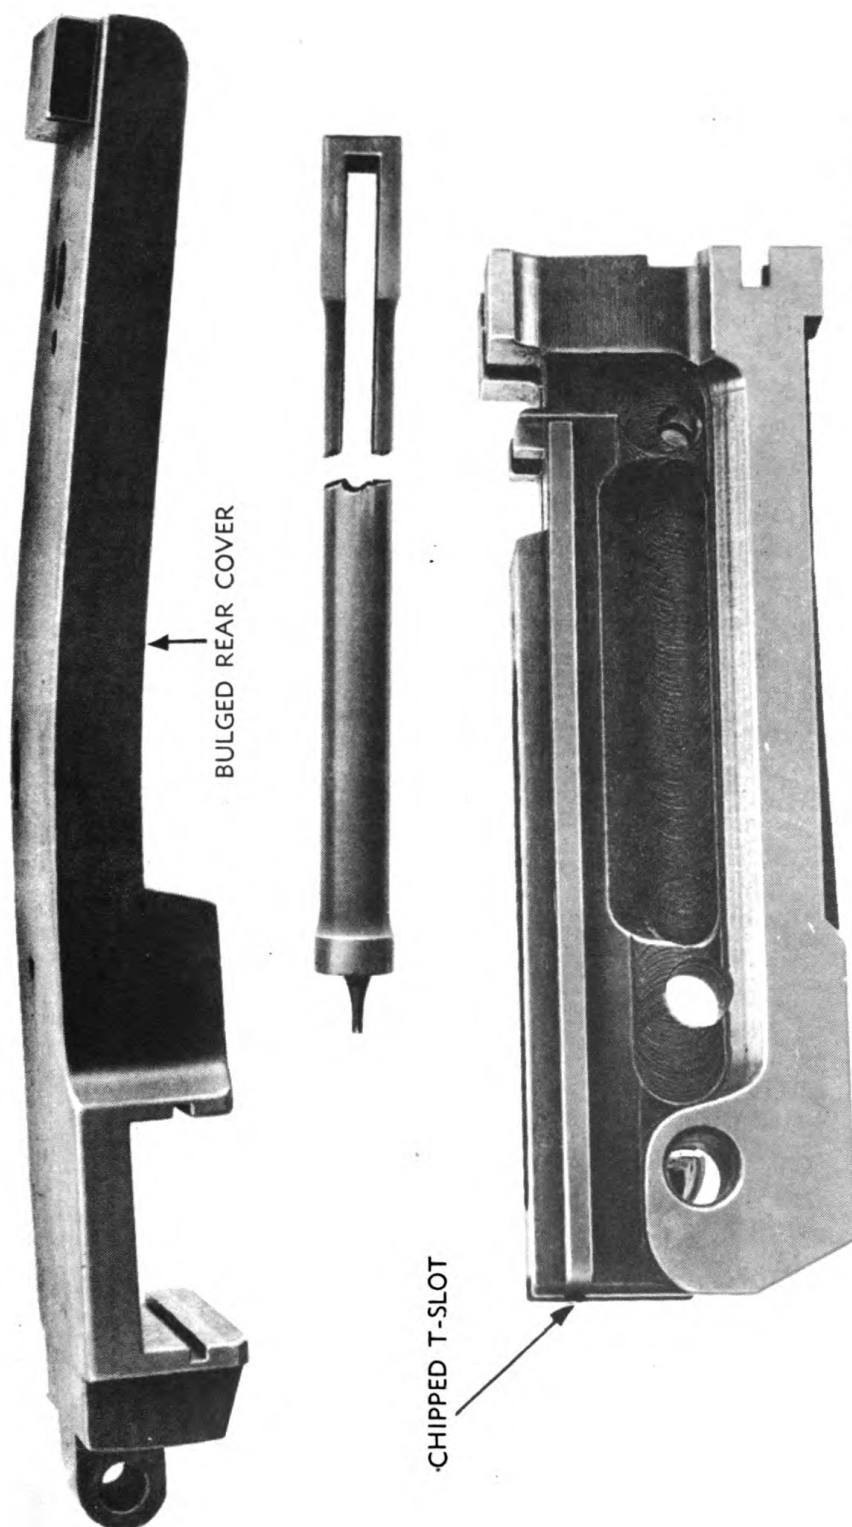
RA PD 23948

**Figure 9 — Damage from Fractured Firing Pin Causing Premature Ignition, BMG, Cal. .30**

Figure 9 exhibits damage to gun caused by premature firing of incoming round by fractured firing pin. This typical accident was caused by fracture of the firing pin during counterrecoil. The firing pin spring drove the firing pin point prematurely into the primer of the incoming round. The explosion of the cartridge chipped the T-slot and bent the cover upward.

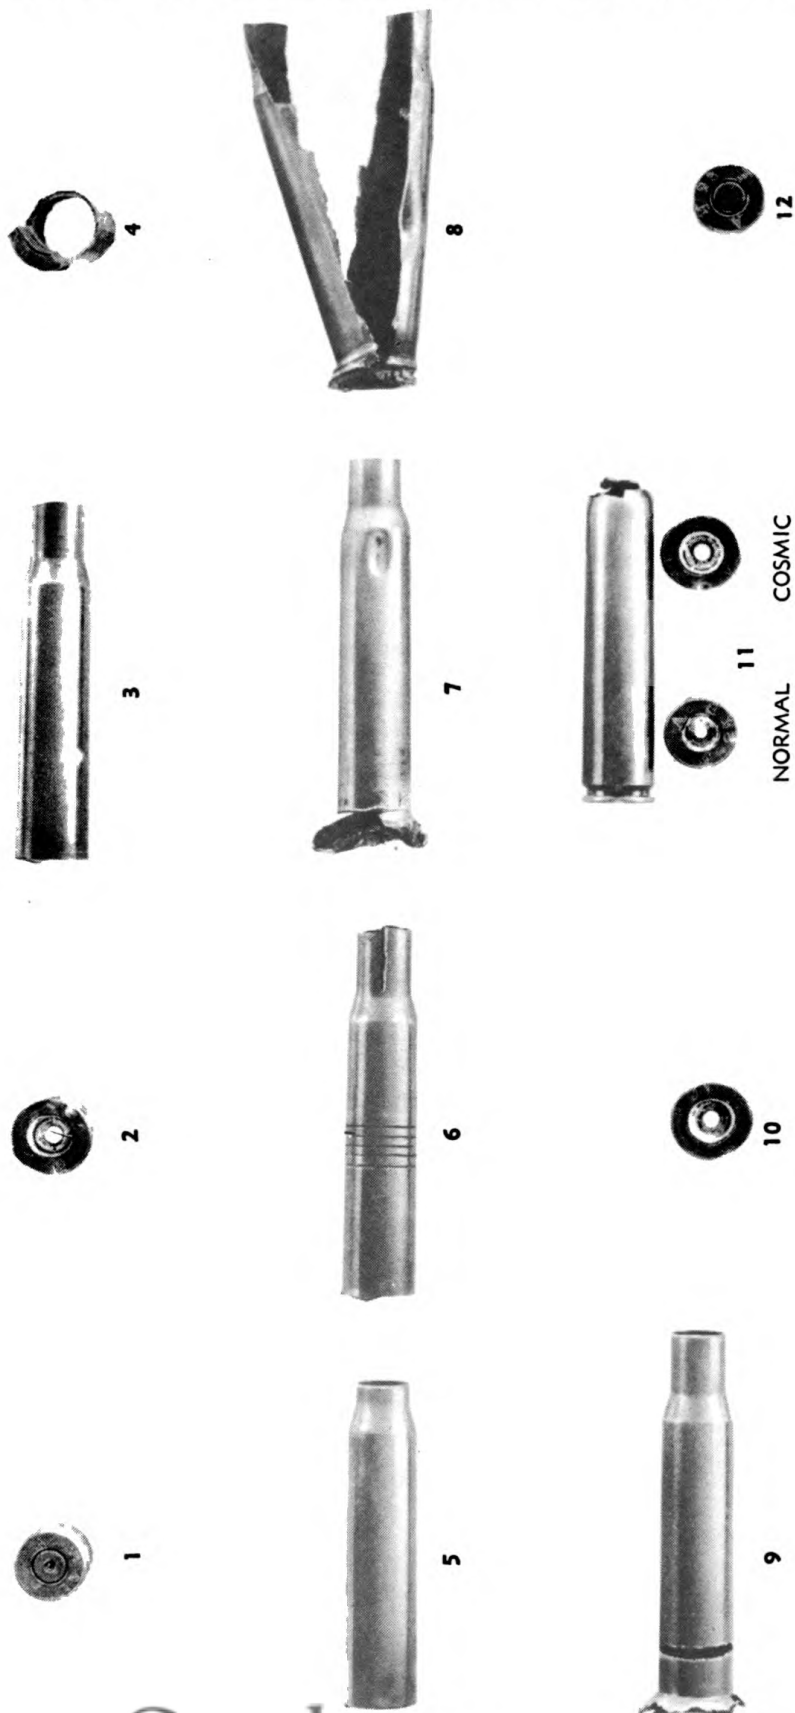
RA PD 23949

Figure 10 shows typical examples of cal. .30 cartridge cases which were subjected to various abnormal firing conditions.

a. No. 1 is the head of a cartridge case subjected to a breech pressure of 75,000 lb per sq in. Observe flattening of the primer cup. A pressure of 75,000 lb per sq in. ordinarily will form an annular bulge on the case immediately forward of the thick head section.

b. No. 2 shows the effect on the case head of a pressure of 98,000 lb per sq in. Such breech pressure enlarges the primer pocket, releasing the powder gases into the action of the rifle. The force of these escaping gases is sufficient to shatter the midportion of the stock, bulge the walls of the magazine outward, bend the floor plate, damage the bolt head, and blow the extractor from the bolt.

c. Nos. 3 and 4 show the effects on fired cases of extremely high breech pressure developed by fast burning powder. These cartridges were loaded with a bursting charge for experimental purposes. In figure 3 note depth of impressions formed on exterior of case from tool marks in the walls of the chamber.

d. No. 5 exhibits the appearance of the case of an 8-mm German cartridge fired in the cal. .30 rifle. This cartridge may be identified by the four crimp marks evenly spaced around the mouth of the case. Excessive breech pressure is developed by the resistance of the oversize (0.317 in. diam) 8-mm bullet.

e. No. 6 exhibits the fired case of a guard cartridge which developed excessive breech pressure. Note the ruptured head and the identification grooves in the wall of the first cone.

f. No. 7 shows the case of a normal round fired in a barrel with grease in the chamber and breech end of bore. Grease or heavy oil in the chamber invariably produces a flute in the forward portion of the first cone of the case. Note the elongated and radially contoured shape of the flute. Observe the ruptured case head.

Figure 10 — Examples of Cartridges Fired Under Abnormal Conditions, Rifle, Cal. .30, M1903A1

g. No. 8 shows the case of a high pressure cartridge fired in a barrel having a longitudinal seam in the walls. Note evidence of excessive breech pressure in the ruptured case head. The longitudinal separation of the case followed a similar separation of the walls of the chamber.

h. No. 9 shows the effects on the case of extremely high breech pressure and excessive headspace. Note evidence of excessive headspace in the separation near head of the case. Evidence of excessive pressure is found in the ruptured case head, and in the depth of the impressions formed on the exterior of the case by tool marks in the walls of the chamber.

i. No. 10 shows the effects of a normal breech pressure of 49,000 lb per sq in. on the head of a soft cartridge case. The first cone of a soft case will be heavily marked from any tool marks in the wall of the chamber. The enlargement of the primer pocket releases the powder gases into the action, damaging the rifle as detailed in paragraph 6 b above.

j. No. 11 exhibits the effect on the case of firing a cartridge with an excessive bullet pull in a chamber coated with COMPOUND, rust-preventive. Note the separation at the second cone and the expanded case head.

k. No. 12 shows the head of a cartridge case with punctured primer. This primer cup shows no indications of high pressure. Compare the radius at the edge of this primer with that of the primer shown in No. 1. When neither the primer nor the fired case show evidence of high pressure, a punctured primer usually indicates a thin primer cup. Occasionally there is a small flash hole in the case.

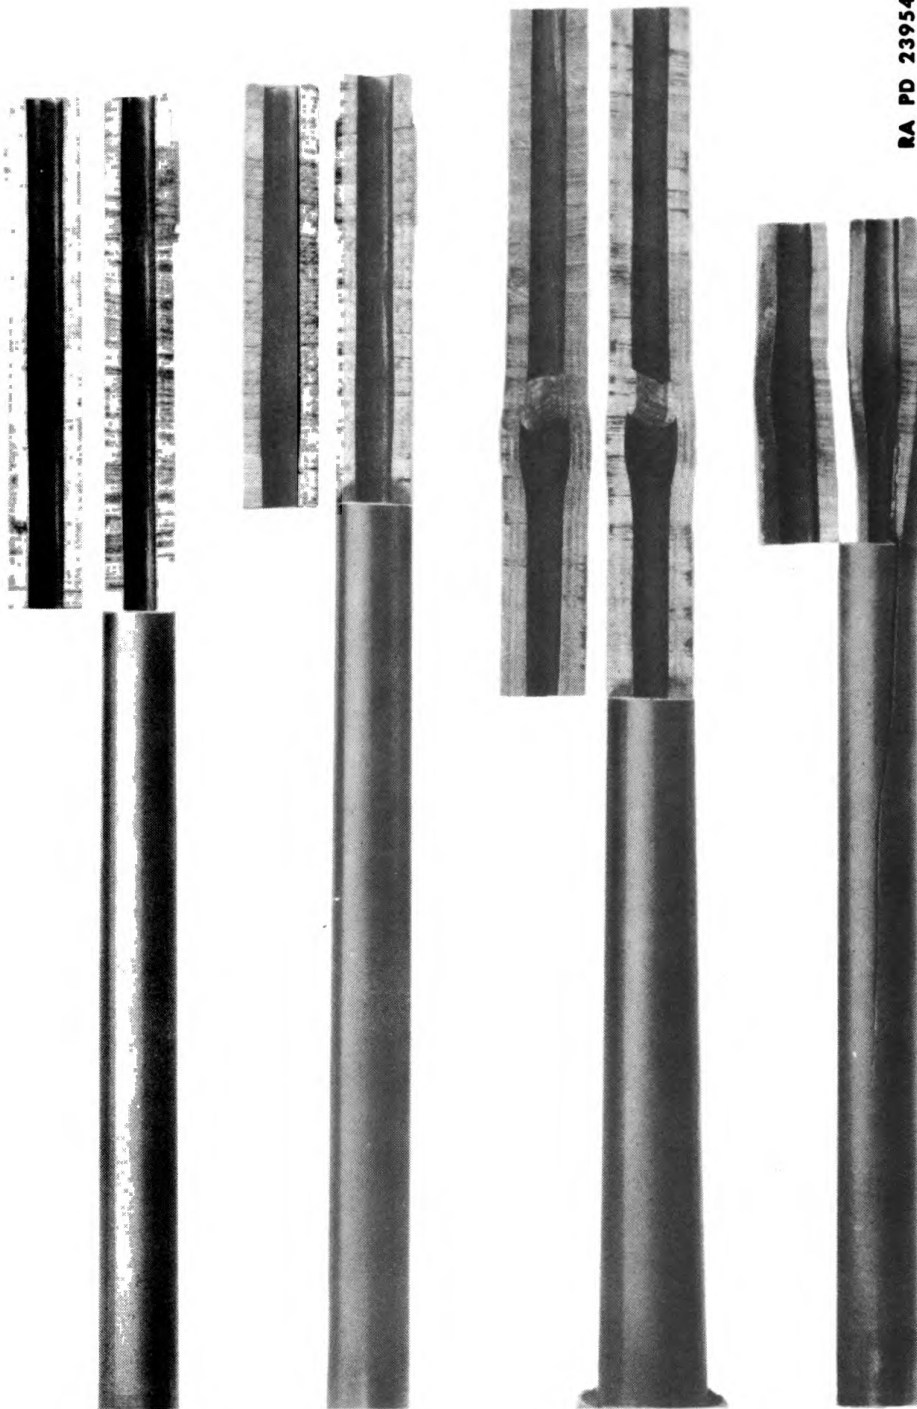
RA PD 23954

**Figure 14 — Damage Caused by Firing with Obstructions in Bore, Rifle, Cal. .30, M1903A1**

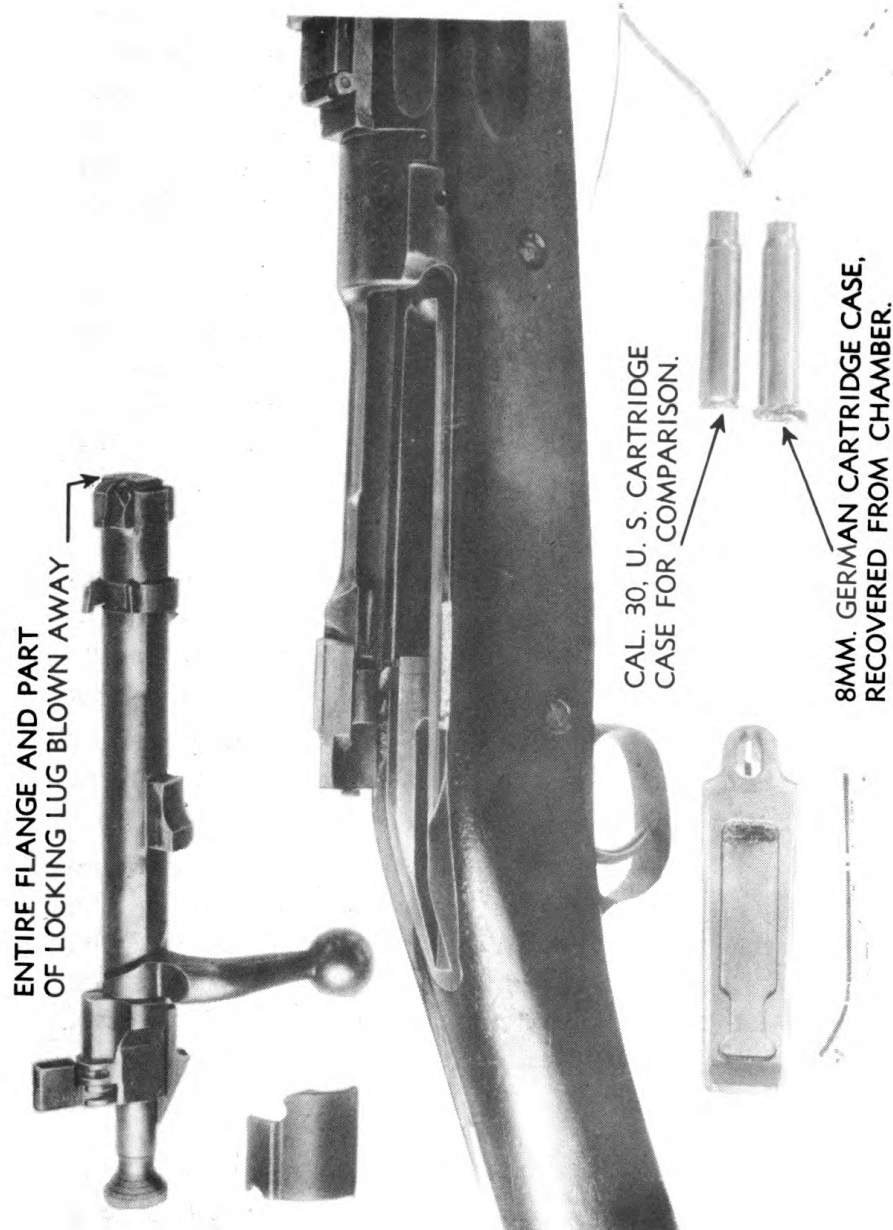
RA PD 23951

Figure 12 shows typical damage to rifle from firing an 8-mm German cartridge. This cartridge may be identified by the four crimp marks evenly spaced around the mouth of the case. Note the fractured bridge of the receiver, the bent extractor and ex-

**Figure 12 — Damage Caused by Firing 8-mm German Cartridge, Rifle, Cal. .30, M1903A1**

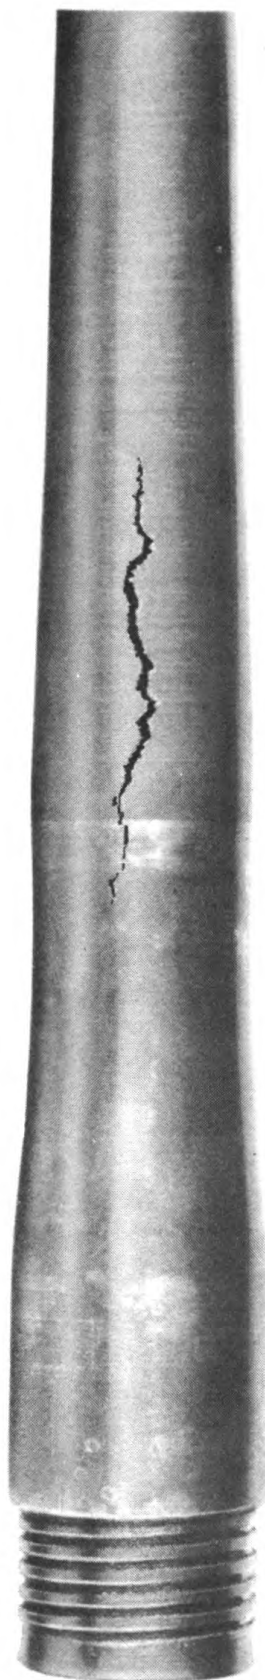
RA PD 23960

**Figure 21 — Damage from Firing Barrels Subjected to Excessively High Temperatures  
During Formation of the Blank, Rifle, Cal. .30, M1903A1**

b. In figures 20 and 21 observe the dark and coarse appearance of the barrel structure. The steel in these barrels was damaged by excessively high temperatures during the formation of the barrel blank.

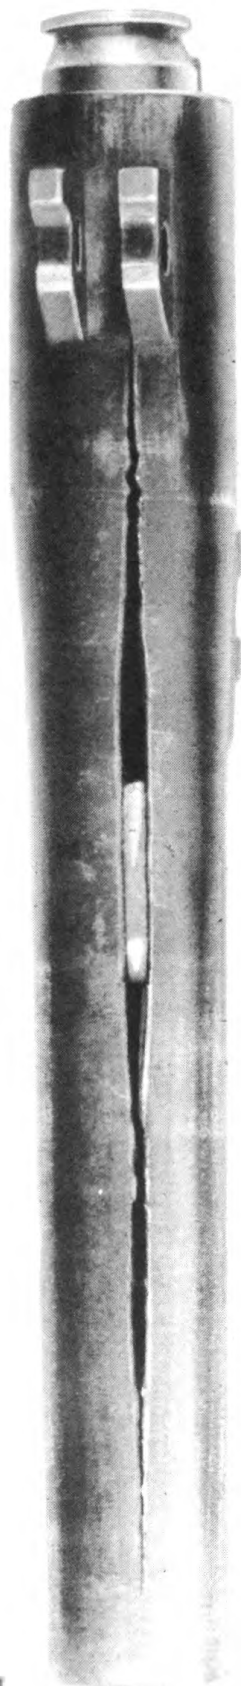
a. Figure 23 exhibits typical damage to pistol from firing a normal round with grease in the chamber and breech end of the bore. The breech pressure developed was sufficient to rupture the head of the cartridge case, releasing the powder gases into the action. Note the bulged housing and the damaged top round from the magazine.

**Figure 23 — Damage Caused by Firing with Grease in Chamber and Bore,  
Automatic Pistol, Cal. .45, M1911**

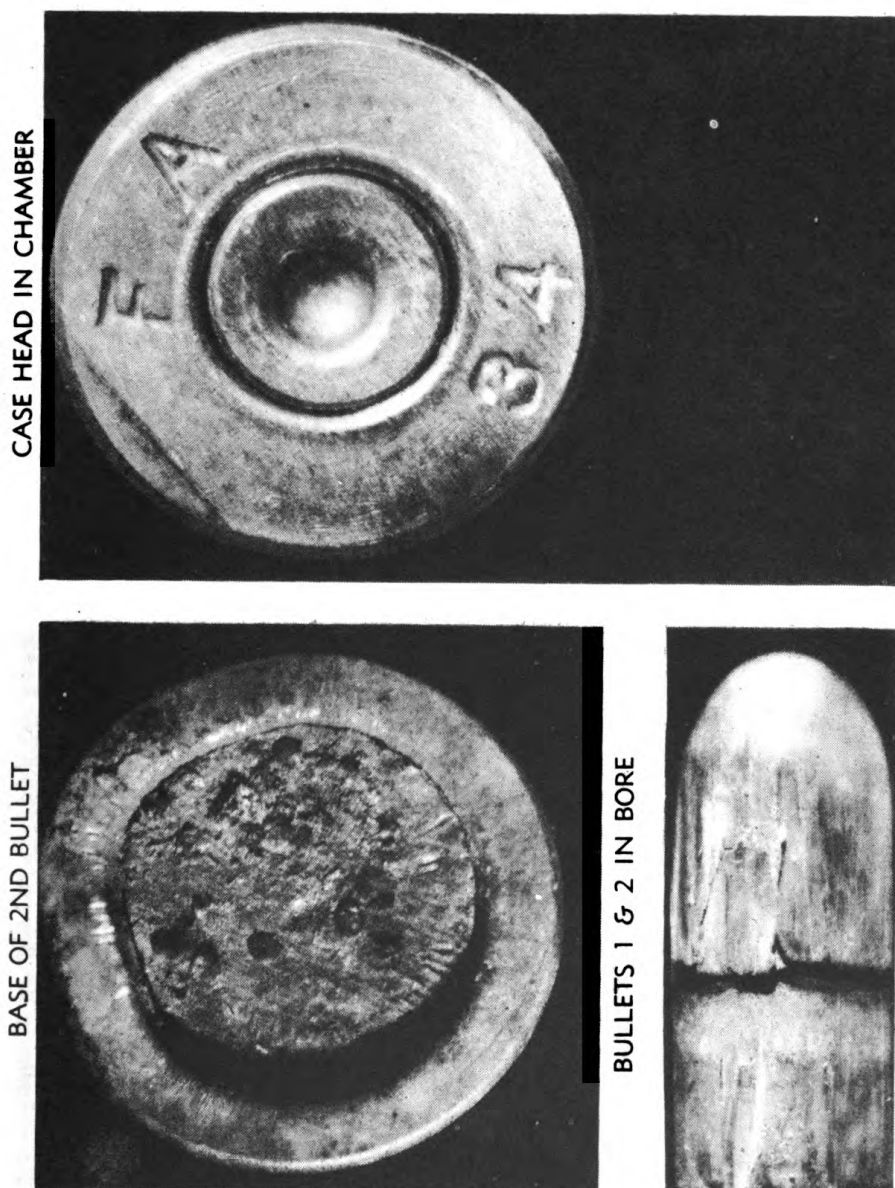
b. Figure 24 exhibits typical damage caused by firing a normal round in a barrel with a bullet in the bore. Bullets may lodge in the bore when fired from a cartridge containing damp powder. In these instances some of the powder grains will be unburned. Figure 25 shows darkened, unburned powder grains adhering to the base of the lodged bullet. Observe the long split in the barrel, and the two bullets recovered from the bore.

**Figure 24 — Damage Caused by Firing with Bullet Lodged in Bore,  
Automatic Pistol, Cal. .45, M1911**

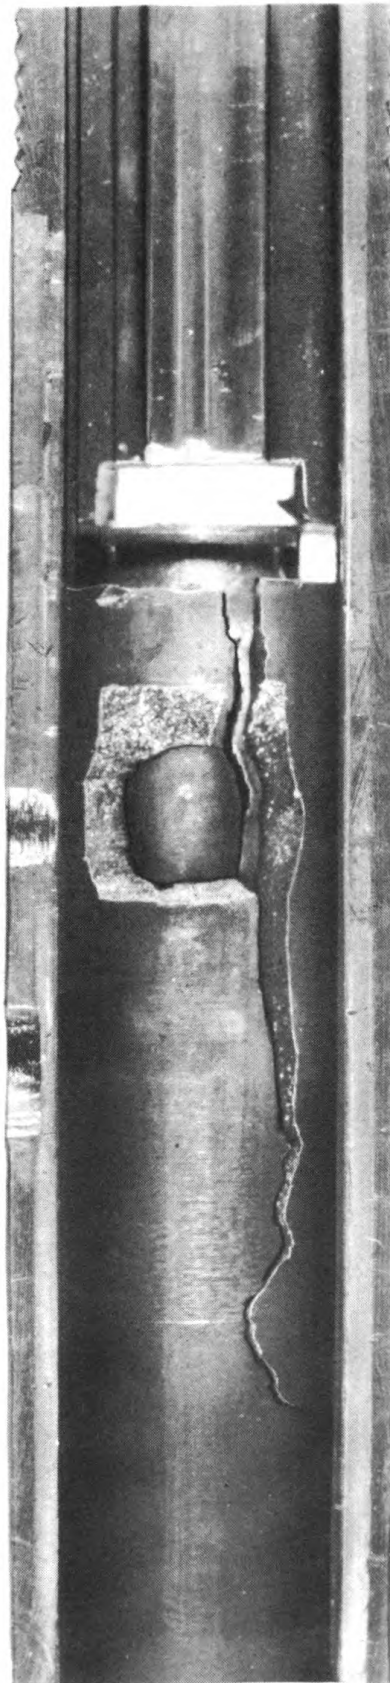
RA PD 23966

b. Figure 27 shows damage to the breech end of the barrel when the metal has become fatigued from long usage. Note the coarse structure of the metal at the break.

**Figure 27 — Damage to Breech End of Barrel Caused by Fatigue of Metal from Long Usage, Automatic Pistol, Cal. .45, M1911**

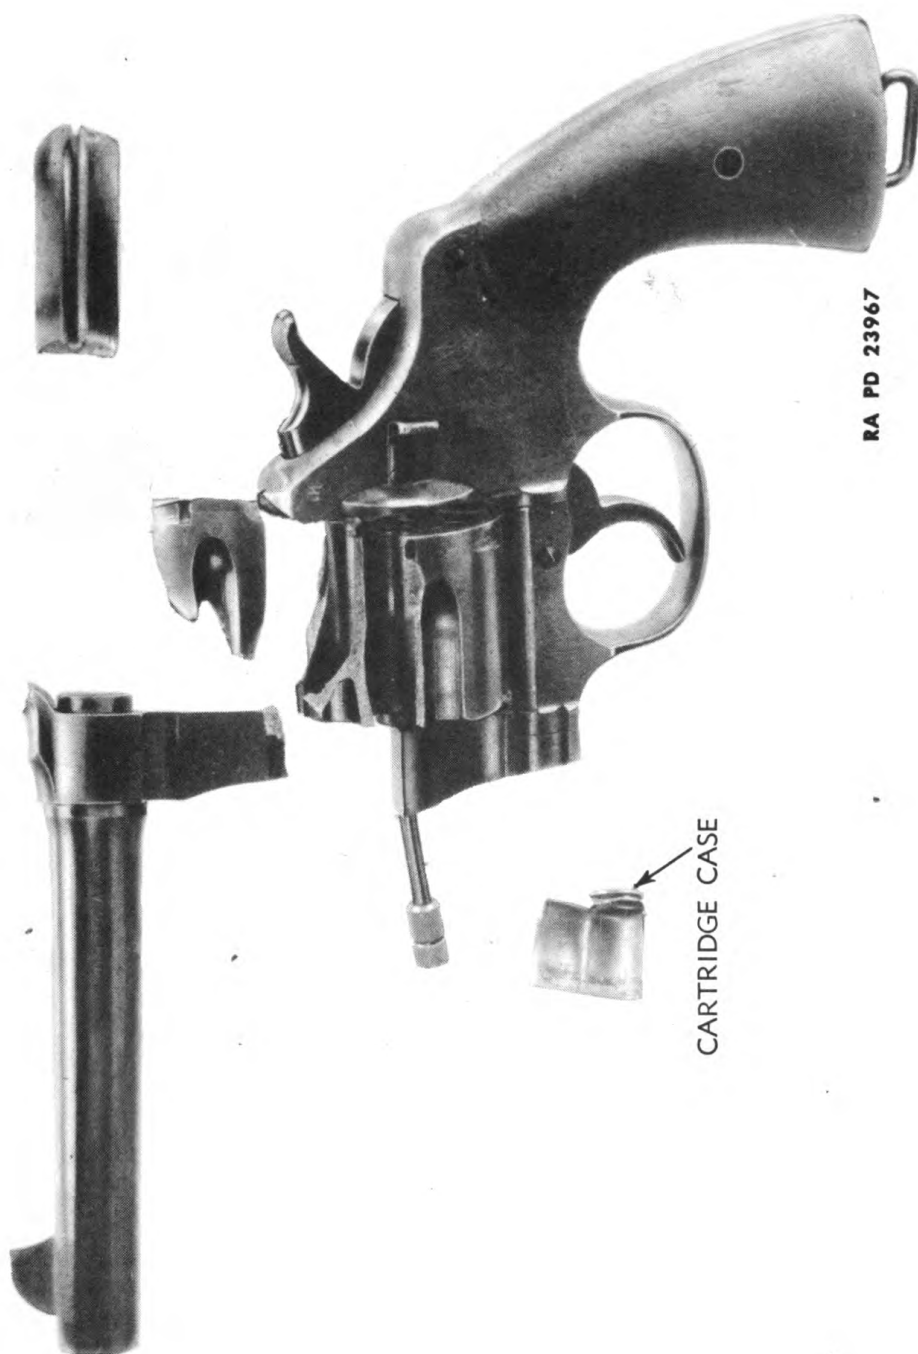
Figure 28 exhibits typical damage from firing a round containing a double charge of powder.

**Figure 28 — Damage from Firing Double Charge of Powder, Colt Revolver, Cal. .45, M1917**
